Revised **FULL RESERVE STUDY**

Iverson Village Condominium

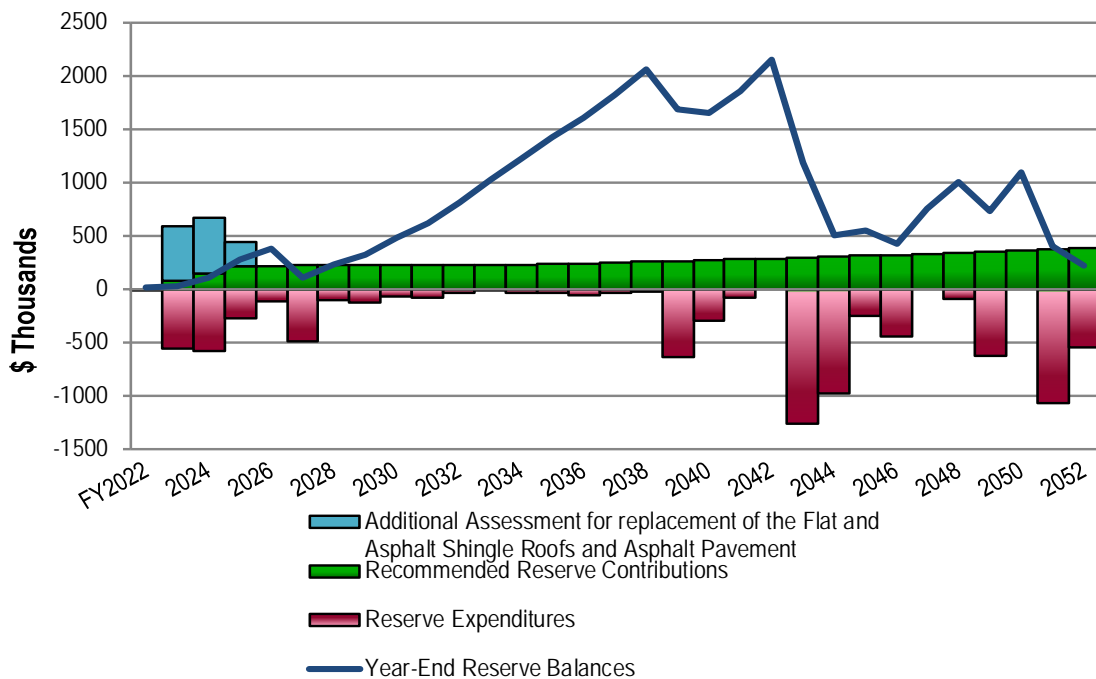
Year	Reserve Contributions (\$)	Reserve Balances (\$)	Year	Reserve Contributions (\$)	Reserve Balances (\$)	Year	Reserve Contributions (\$)	Reserve Balances (\$)
2023	580,828	24,106	2033	222,800	1,025,232	2043	290,700	1,178,512
2024	666,153	106,797	2034	222,800	1,221,098	2044	299,400	496,097
2025	437,997	269,444	2035	229,500	1,422,945	2045	308,400	550,129
2026	216,300	373,769	2036	236,400	1,606,163	2046	317,700	422,058
2027	222,800	103,966	2037	243,500	1,819,562	2047	327,200	753,358
2028	222,800	223,728	2038	250,800	2,052,575	2048	337,000	999,857
2029	222,800	320,038	2039	258,300	1,676,942	2049	347,100	723,891
2030	222,800	472,781	2040	266,000	1,650,127	2050	357,500	1,087,709
2031	222,800	618,958	2041	274,000	1,849,298	2051	368,200	393,423
2032	222,800	806,412	2042	282,200	2,145,431	2052	379,200	220,586

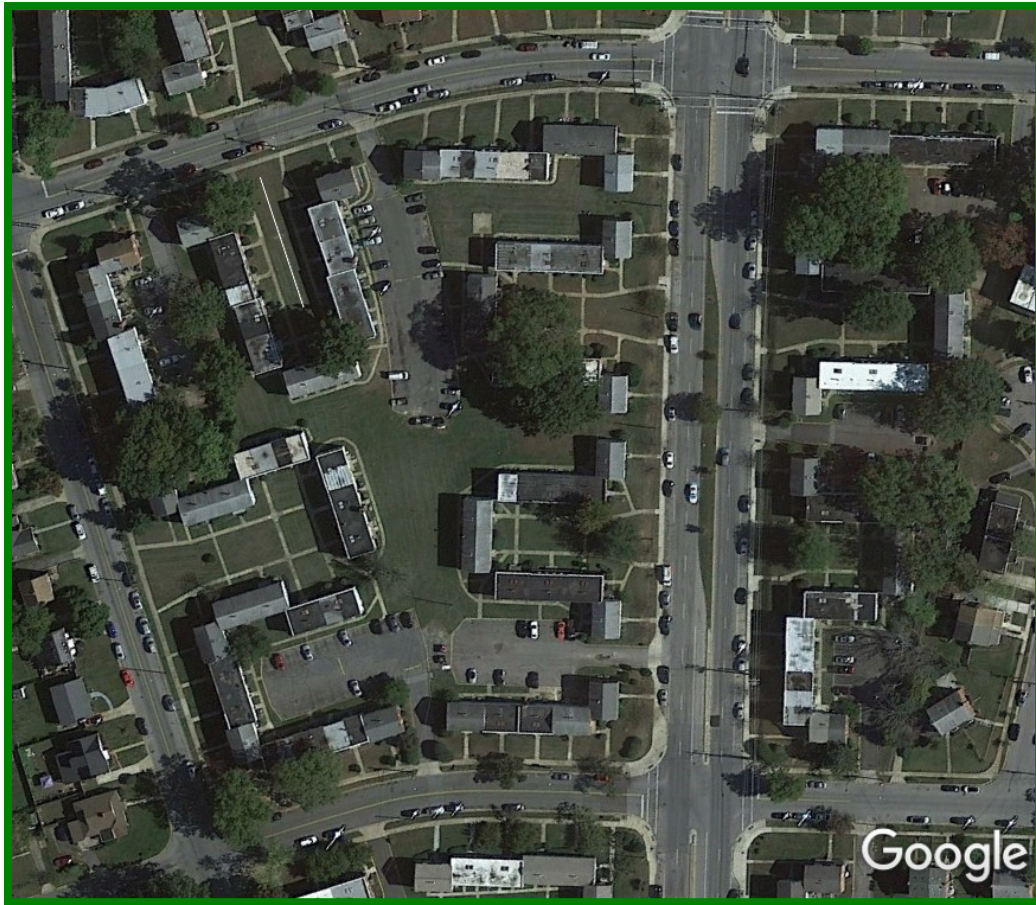
Our investigation includes Reserve Components or property elements as set forth in your Declaration. The Expenditure tables in Section 3 list the elements contained in this study. Our analysis begins by segregating the property elements into several areas of responsibility for repair and replacement.

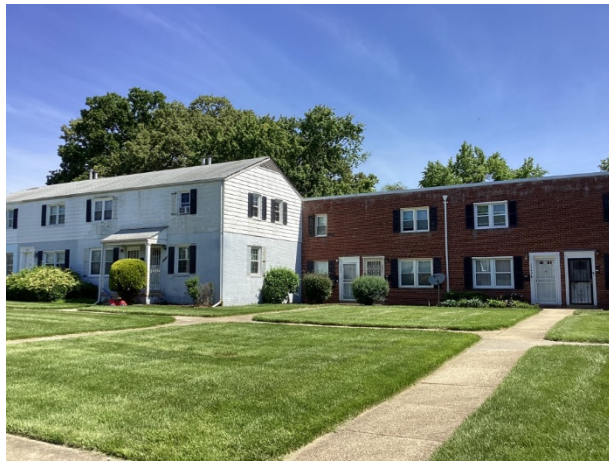
Front and side elevation overview

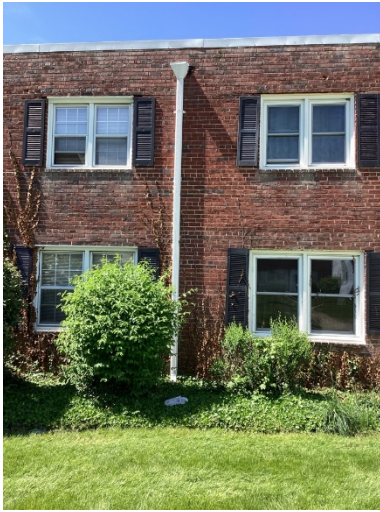
Aluminum downspout and scupper overview

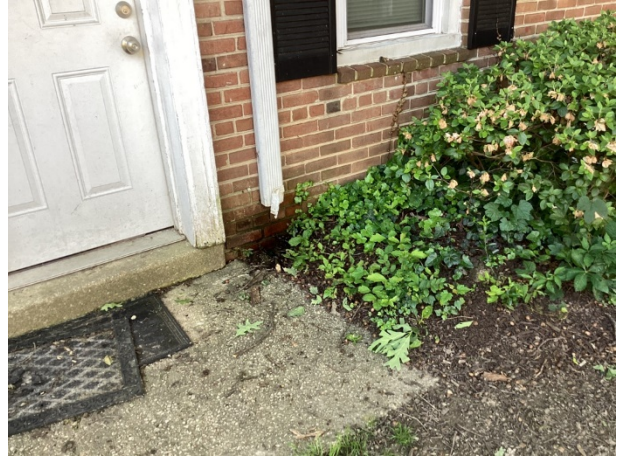
Loose fastener and improper drainage

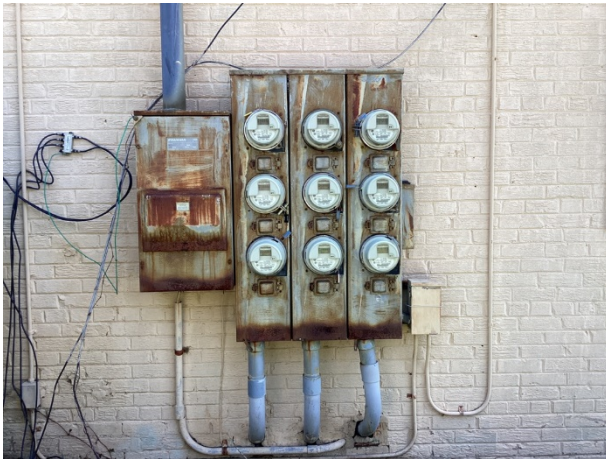
Meter stack overview with rust

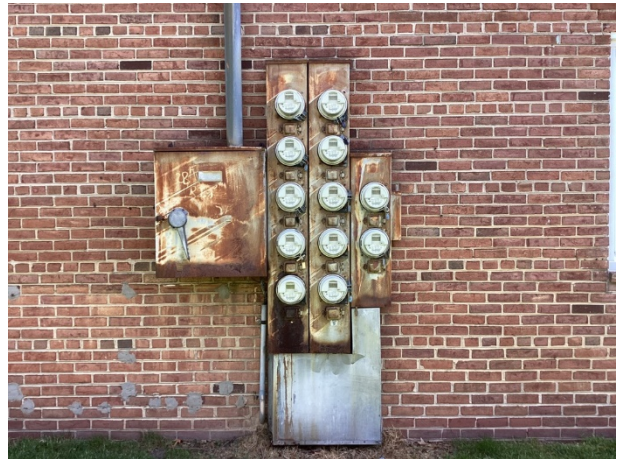
Meter stack overview with rust

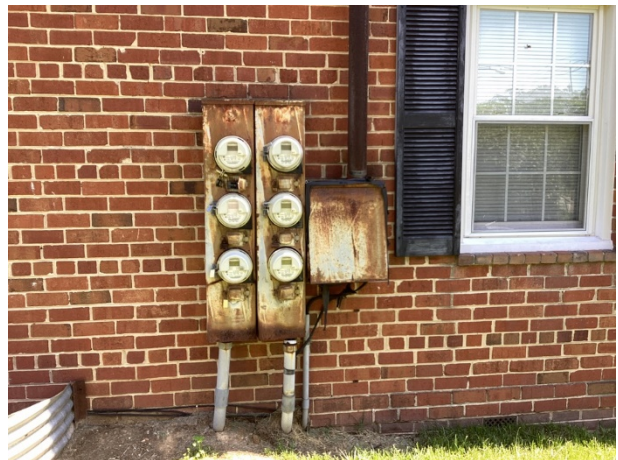
Meter stack overview with rust

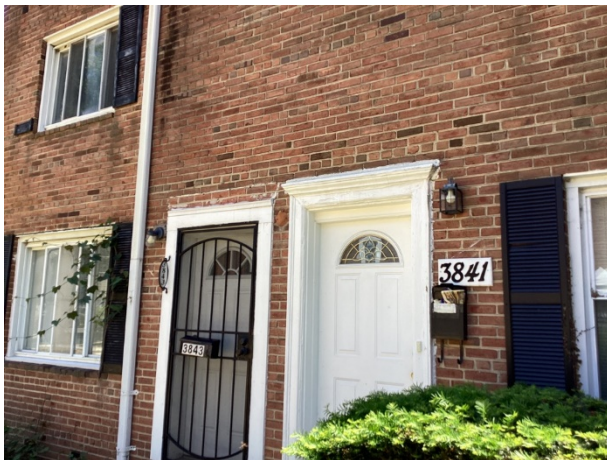
Exterior light fixtures

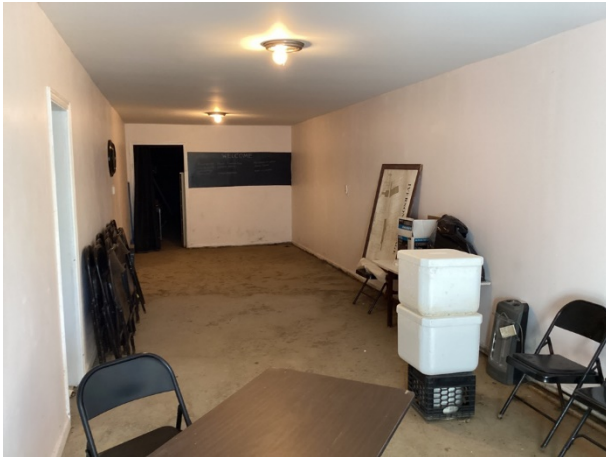
Meeting room overview

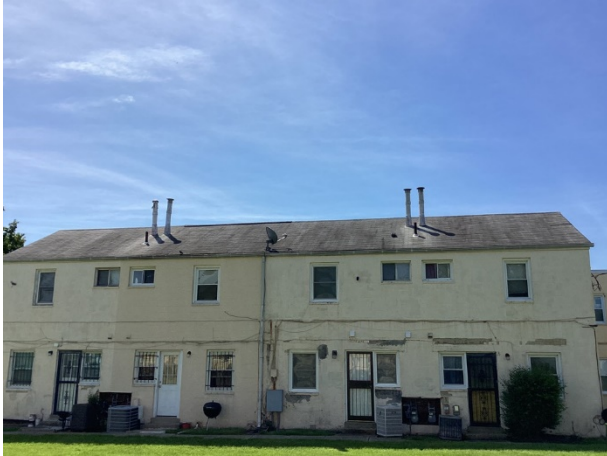
¹ We quantify the roof area in squares where one square is equal to 100 square feet of surface area.

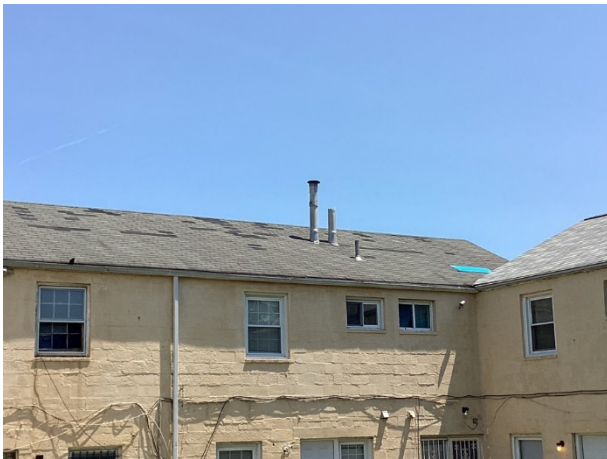
Roof overview with replacements

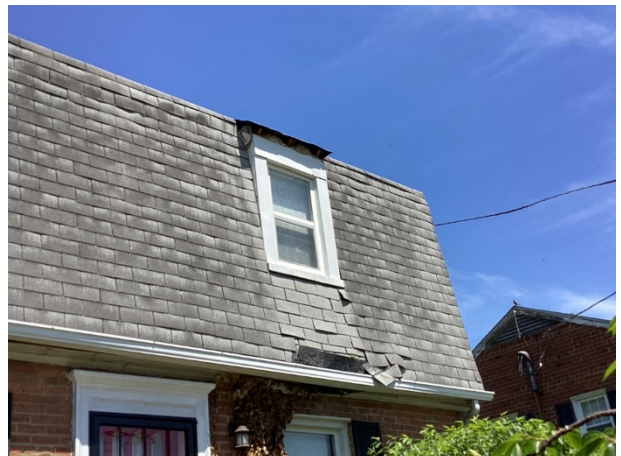
Shingle failure and exposed insulation

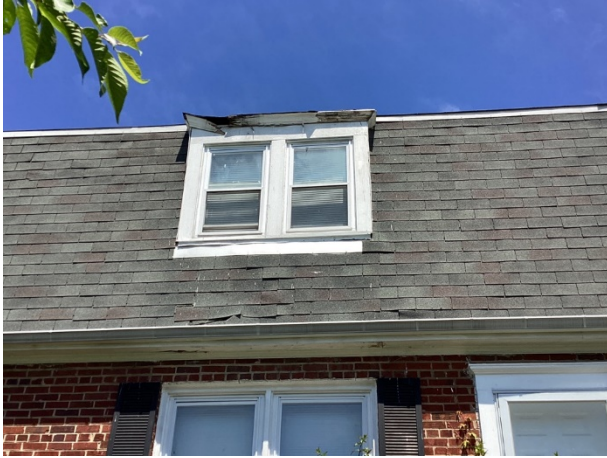
Shingle curl and fascia damage

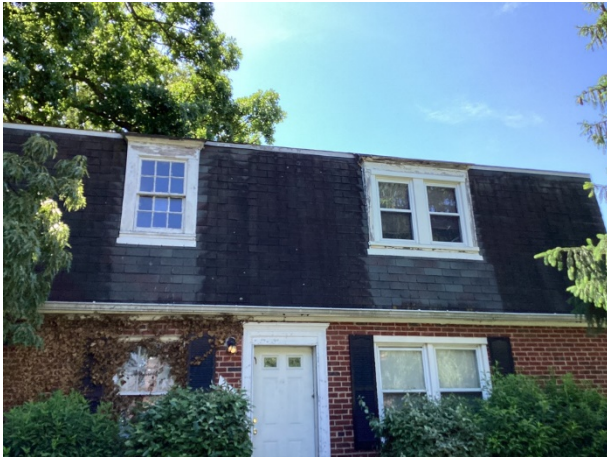
Staining and organic growth

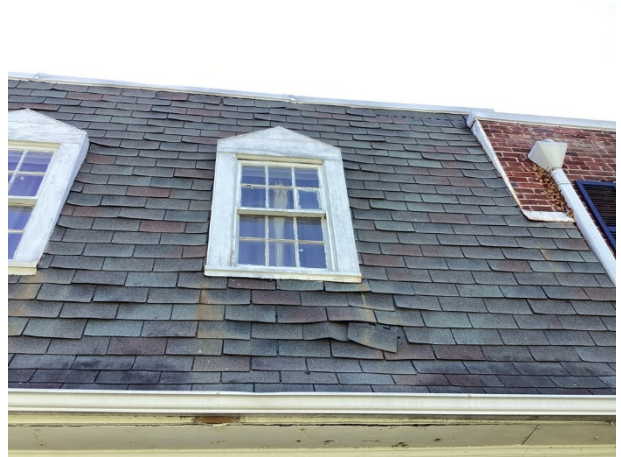
Loose and curled shingles

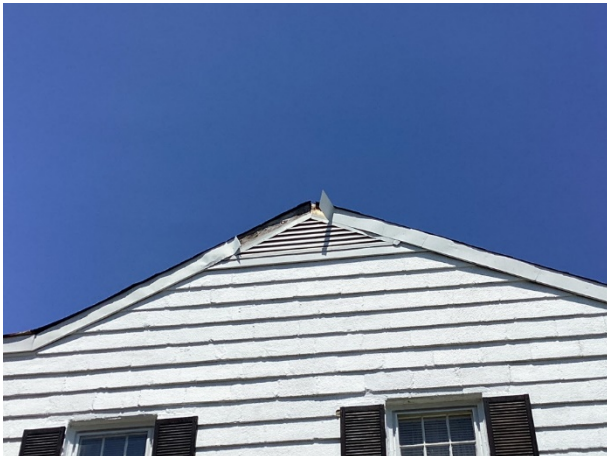
Missing fascia board

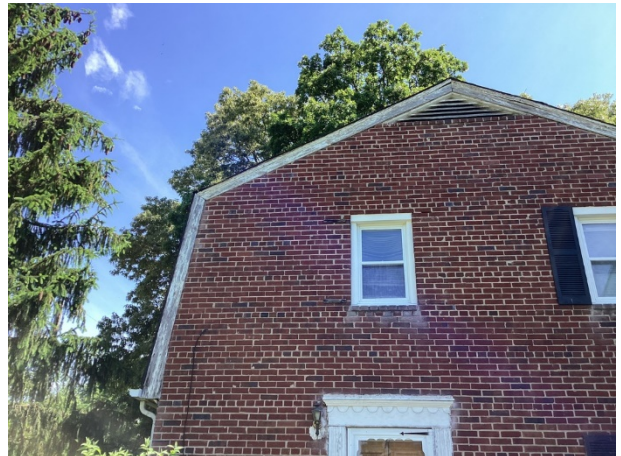
Wood fascia deterioration

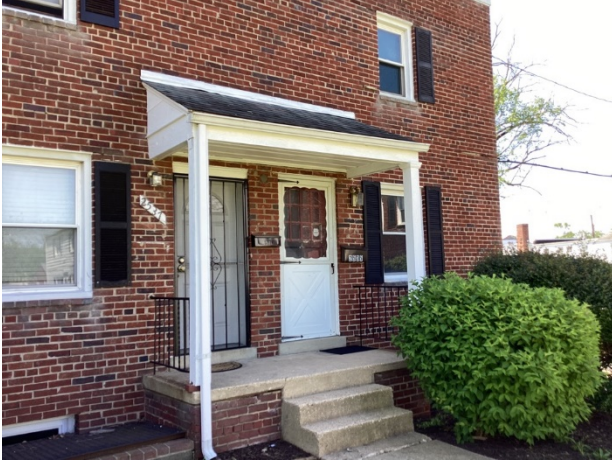
Portico roof overview

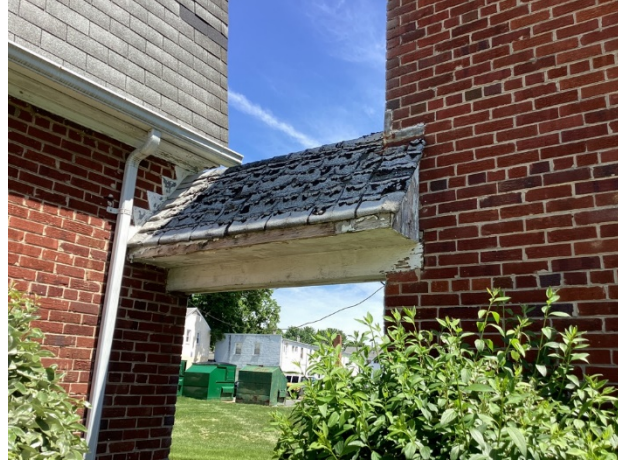
Breezeway roof deterioration

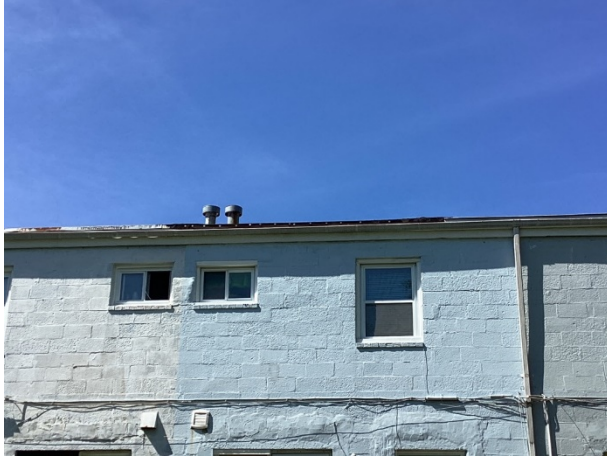
Condition: Poor overall with previous repair and flashing deflection evident. Management and the Board report an extensive history of leaks with on-going leaks reported.

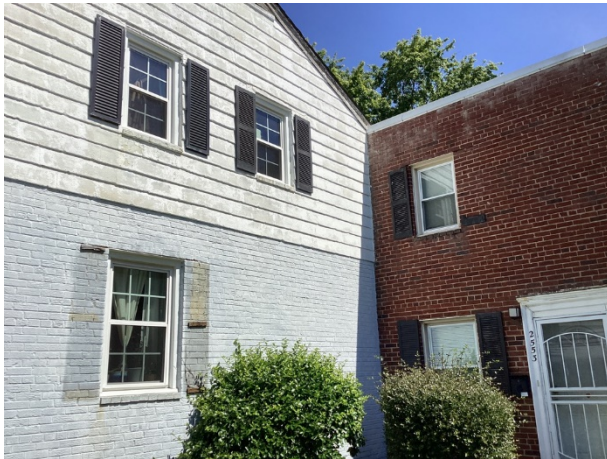
Vinyl shutters with missing and damaged shutters

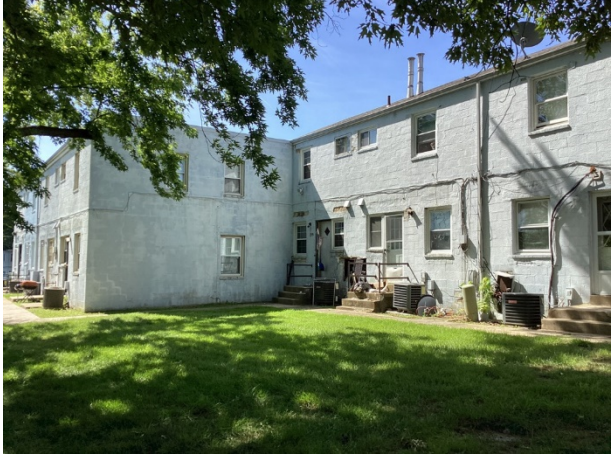
Conditions: The façade and coating are in fair overall condition with spalls, finish deterioration, cracks, and previous repairs evident.

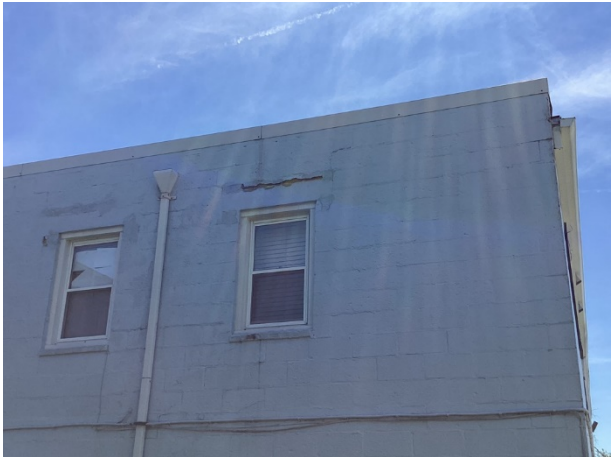
Finish deterioration

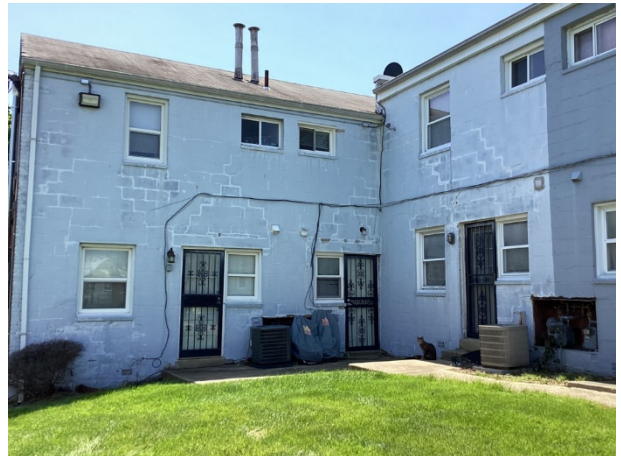
CMU cracks and finish deterioration

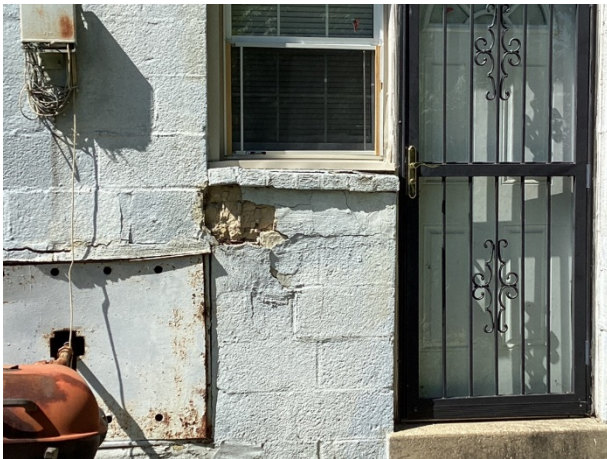
CMU cracks and spall

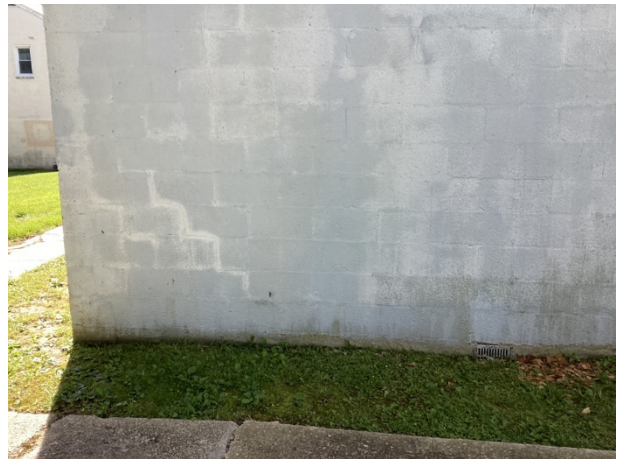
CMU cracks and staining

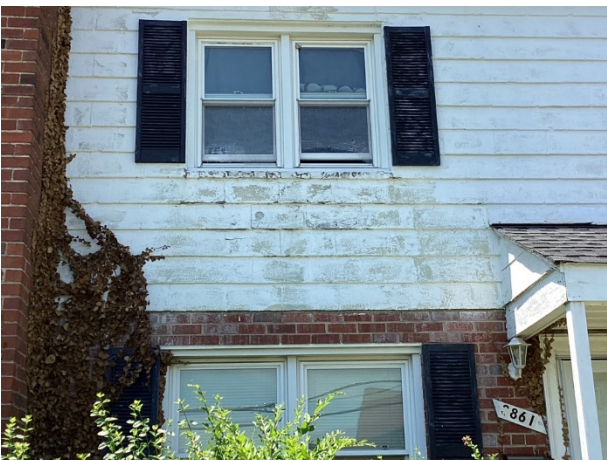
CMU spalls and staining

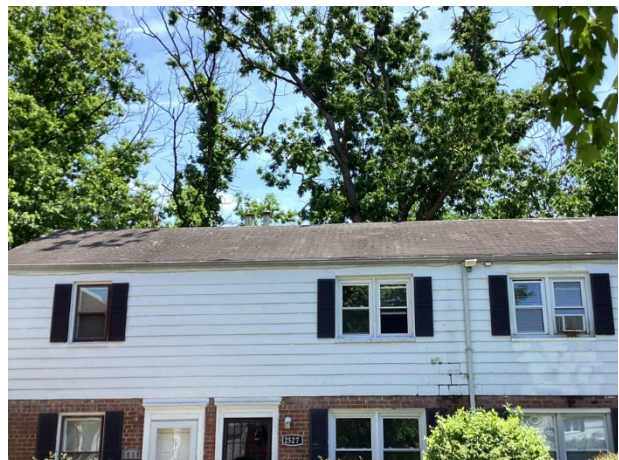
CMU cracks and staining

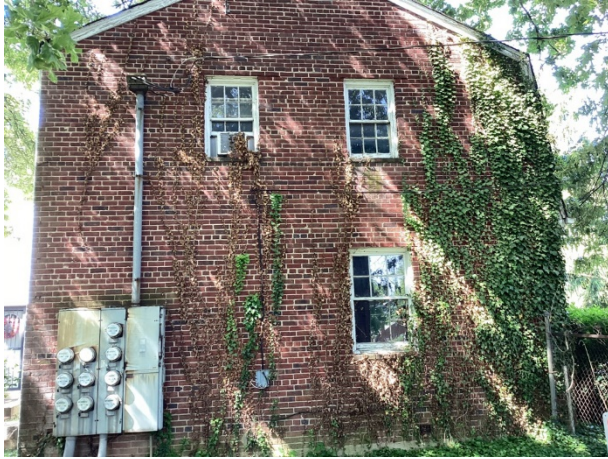
Masonry walls overview

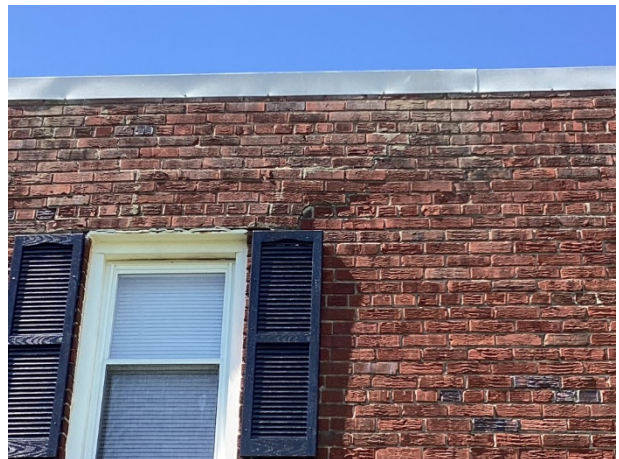
Rust jacking and steps cracks

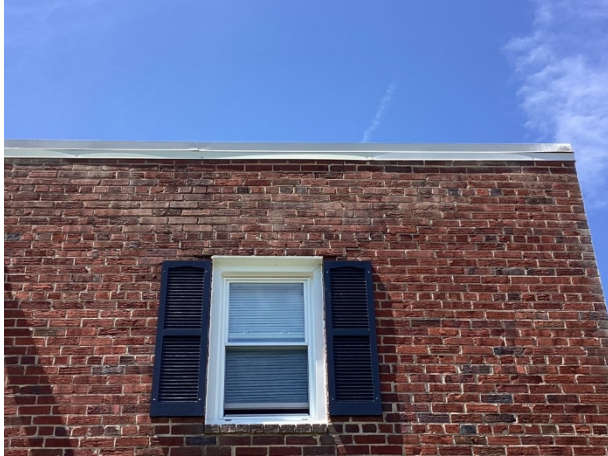
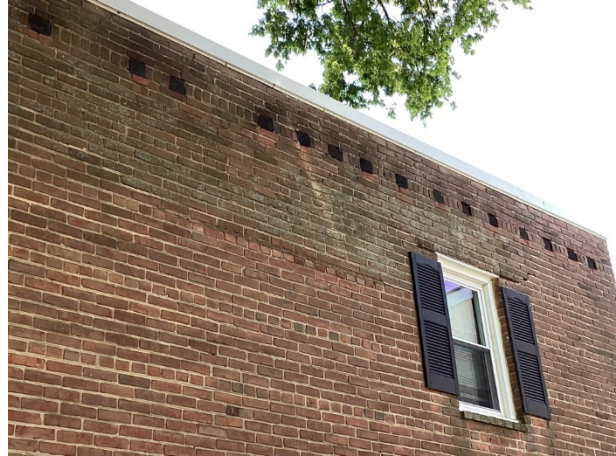
Excessive step cracks at 2522 Iverson Street

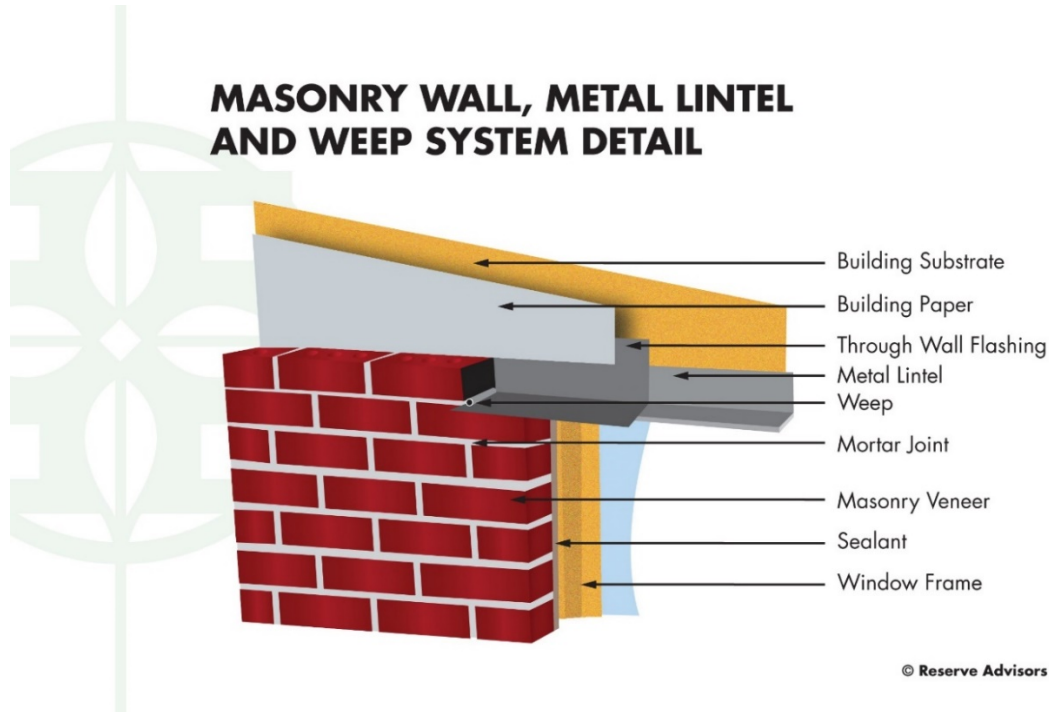
Priority/Criticality: Defer only upon opinion of independent professional or engineer

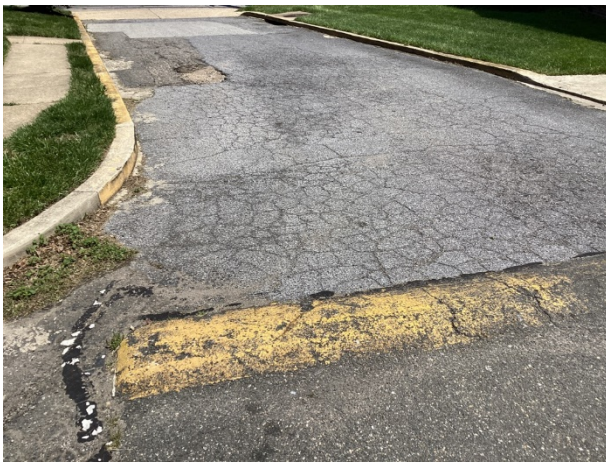
Asphalt pavement overview with speed bump, alligator cracks and pot hole formation

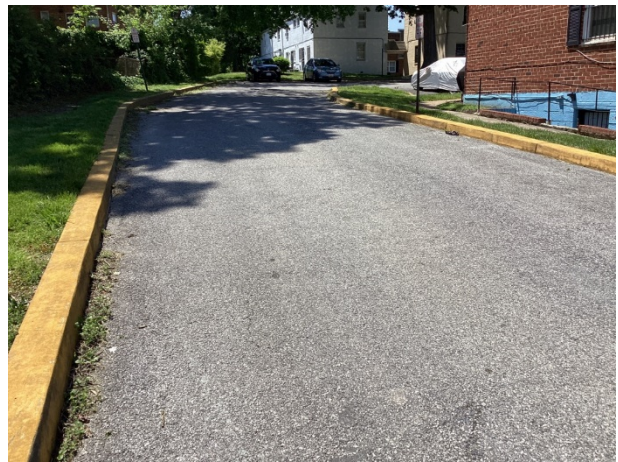
Asphalt pavement parking lot overview

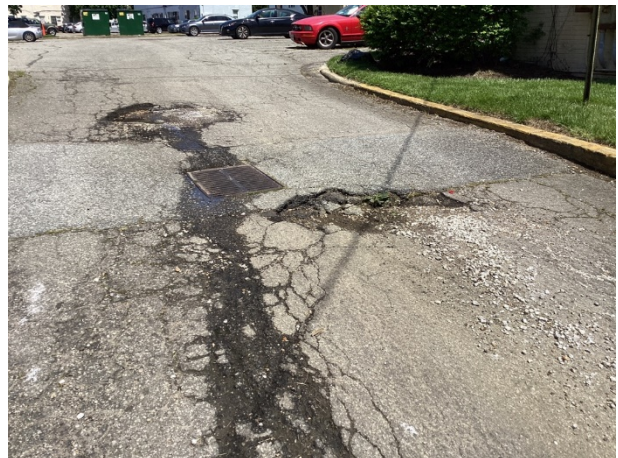
Pavement pothole formation

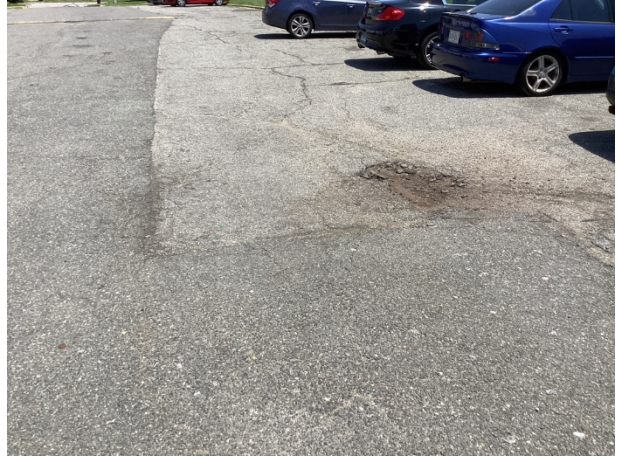
Asphalt pavement parking lot overview with cracks

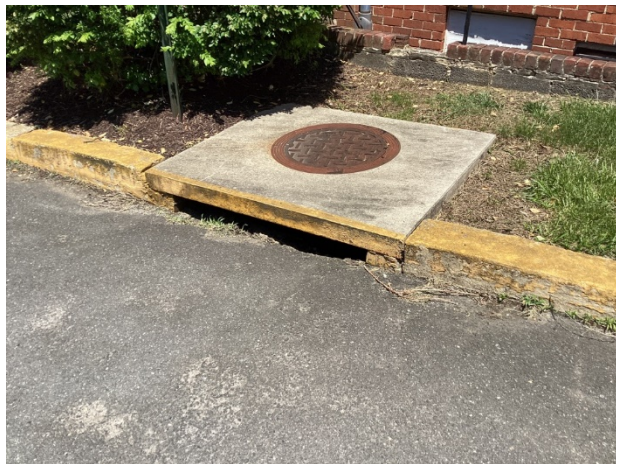
Catch basin overview

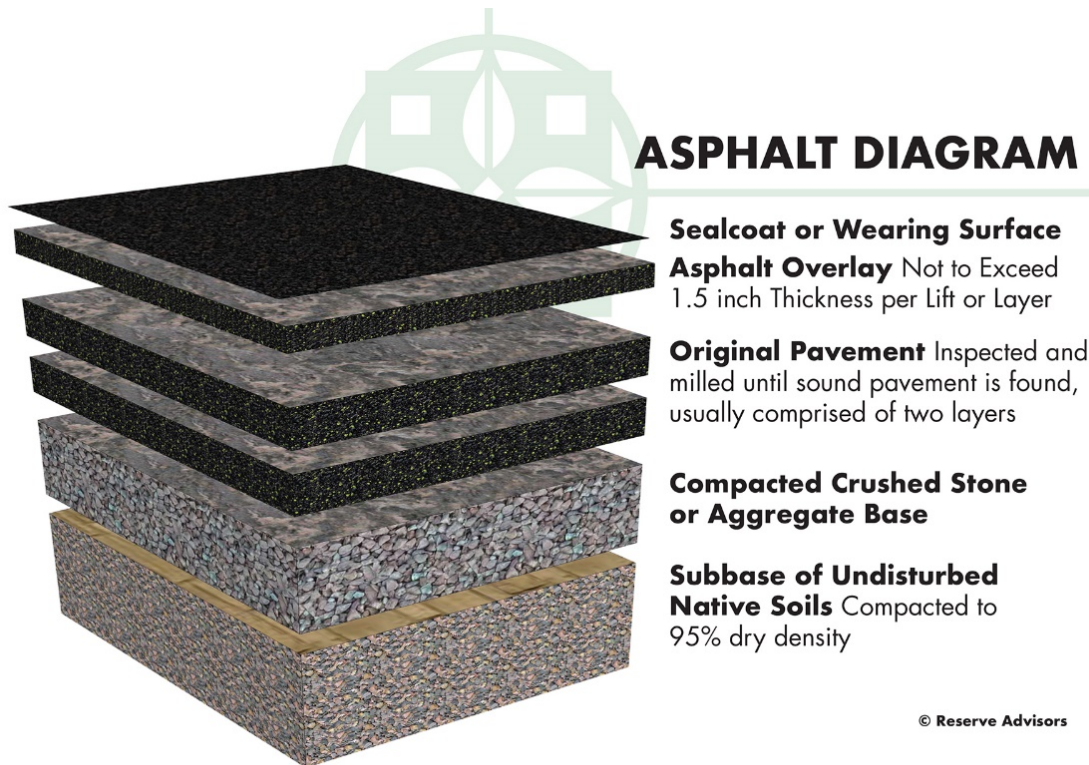
The initial installation of asphalt uses at least two lifts, or two separate applications of asphalt, over the base course. The first lift is the binder course. The second lift is the wearing course. The wearing course comprises a finer aggregate for a smoother more watertight finish. The following diagram depicts the typical components although it may not reflect the actual configuration at Iverson Village:

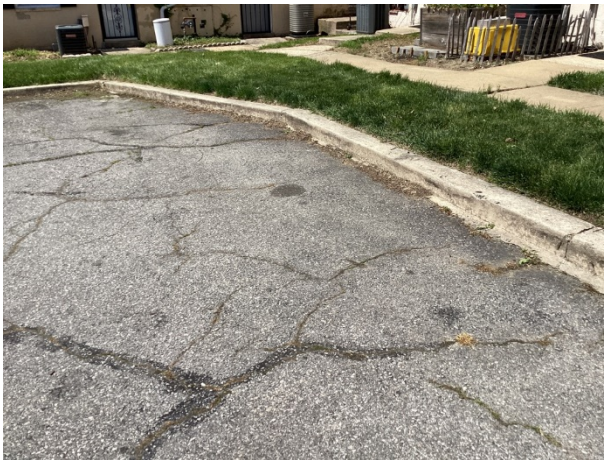
Concrete curb overview

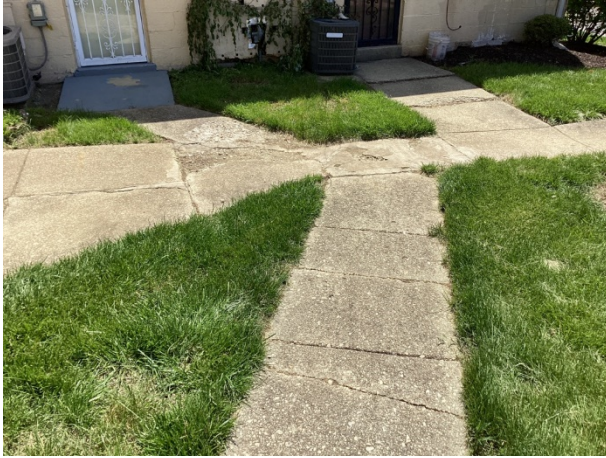
Concrete sidewalk overview with scaling

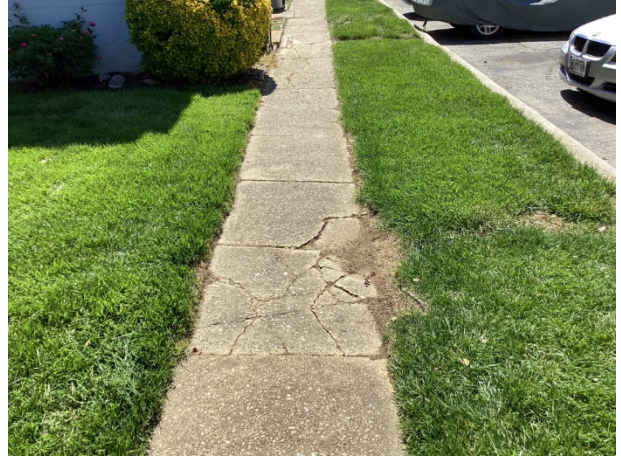
Concrete sidewalk overview with cracks

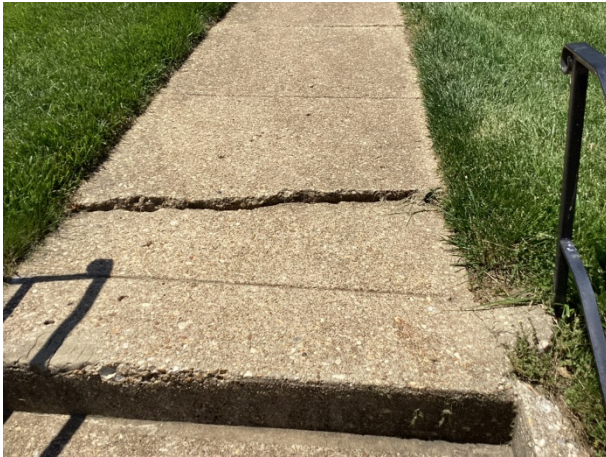
Sidewalk trip hazard near 3859 26th Avenue

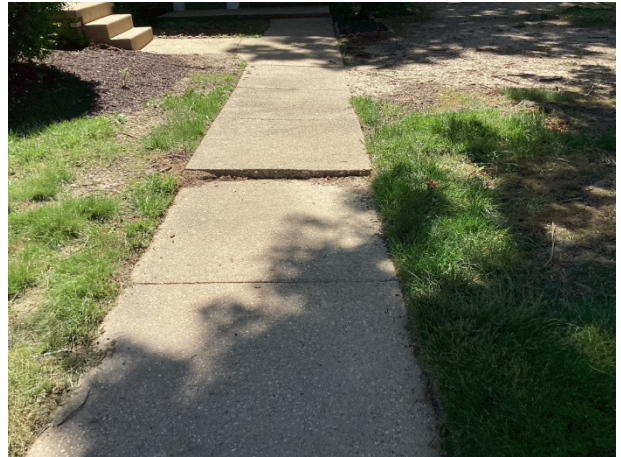
Sidewalk trip hazard near 3902 25th Avenue

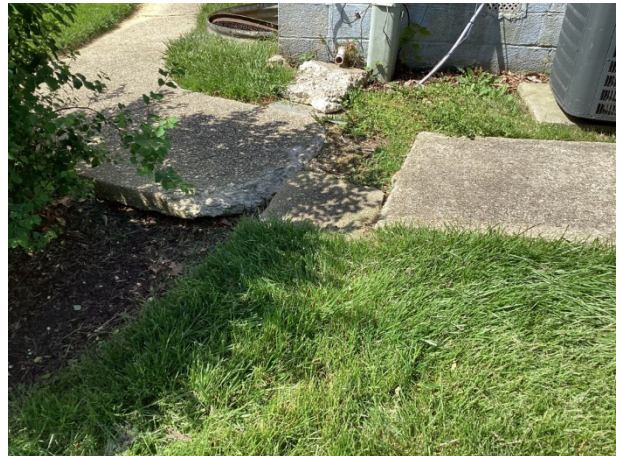
Sidewalk cracks and undermining

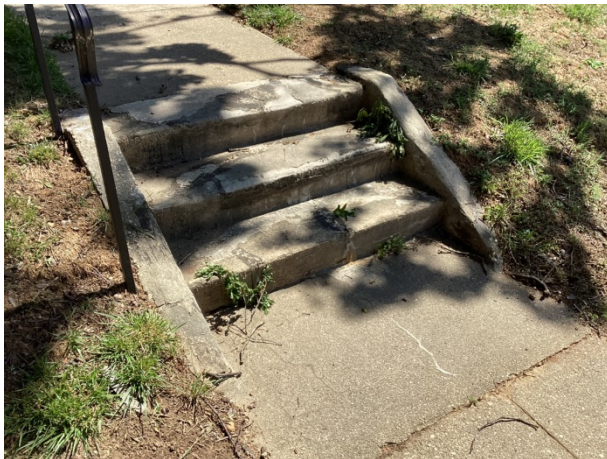
Concrete stair overview with scaling

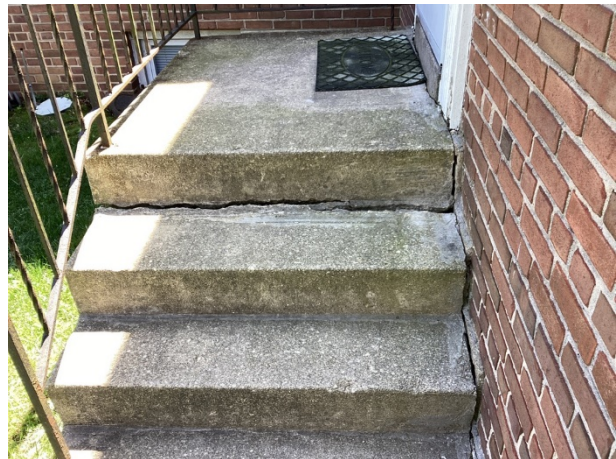
Stair settlement and cracks

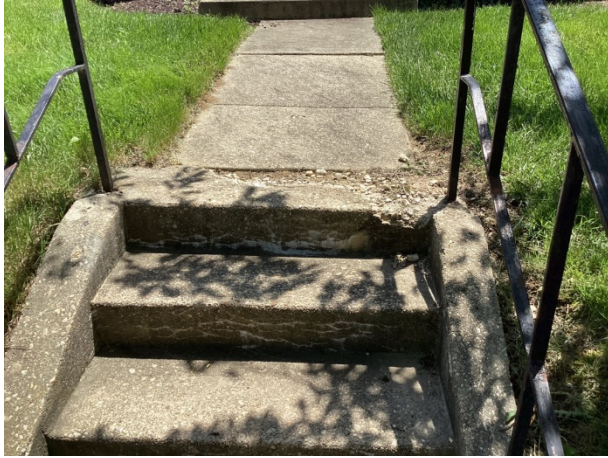
Concrete stairs deterioration

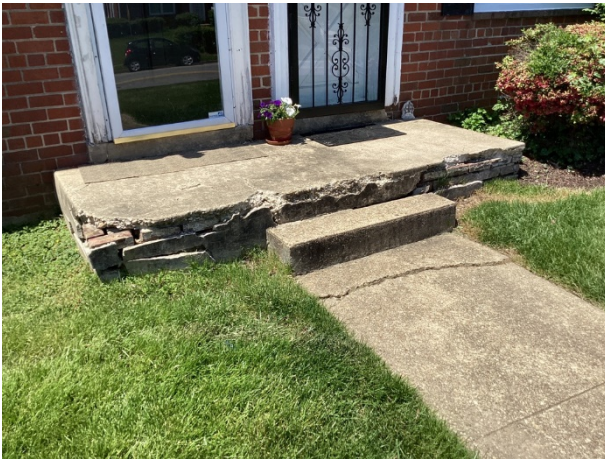
Concrete stoop overview with spalls

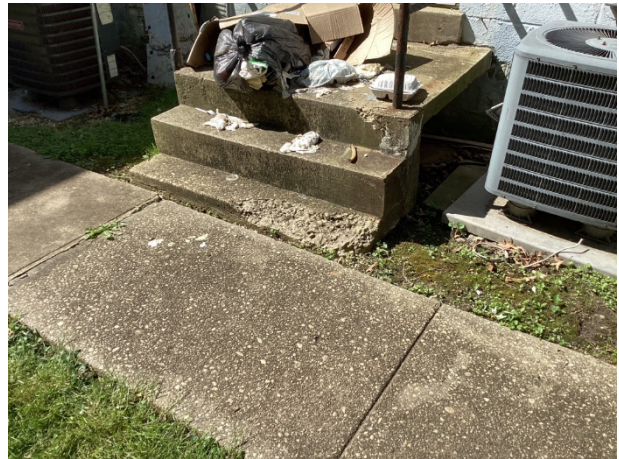
Concrete stoop cracks

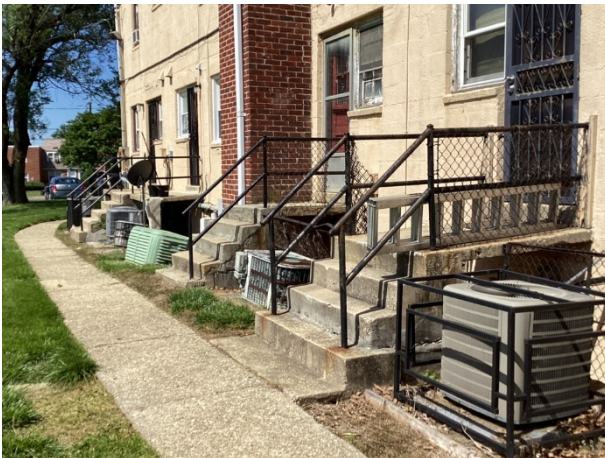
Concrete stoops overview

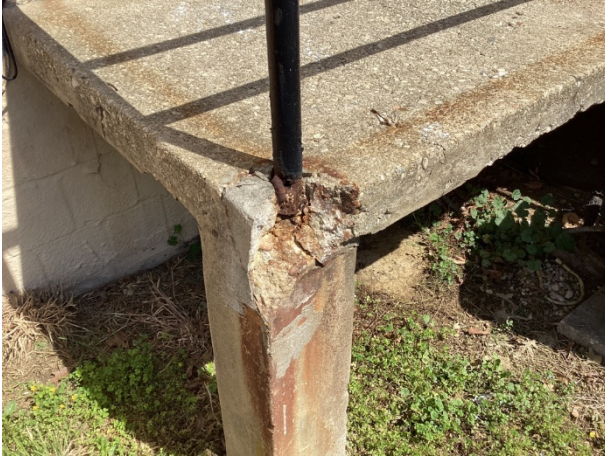
Concrete spall with rust

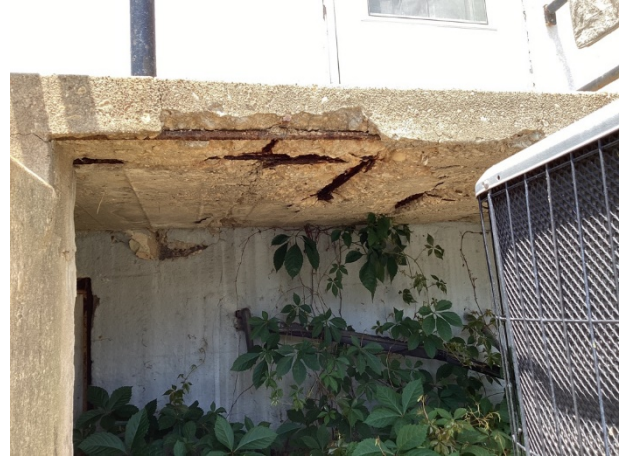
Exposed rebar at 3851 26th Avenue

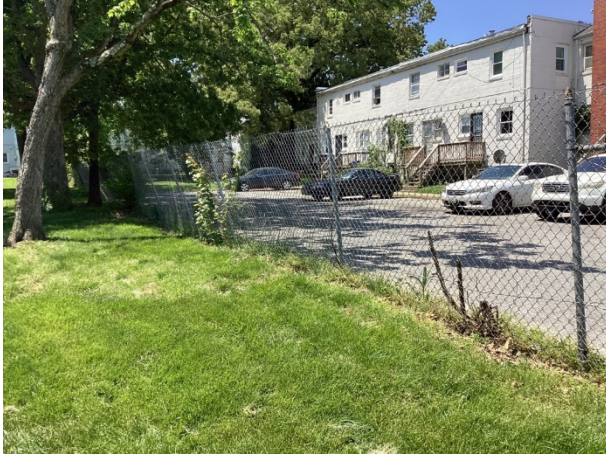
Chain link fence with leaning sections

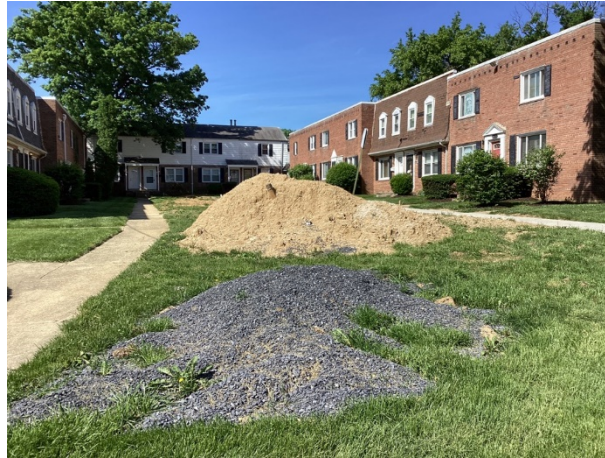
Subsurface utility pipes repair

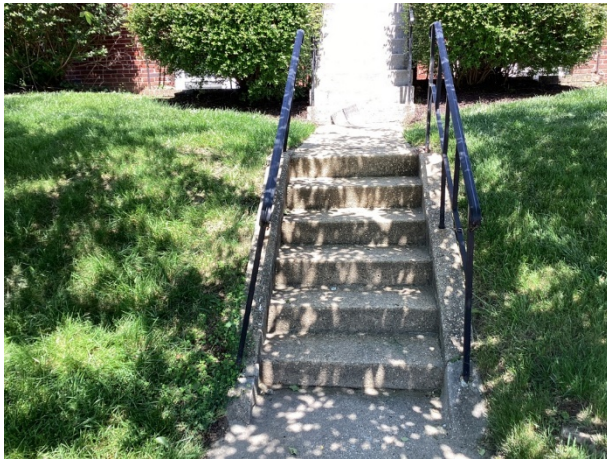
**Steel railing overview with leaning section at
2504 Iverson Street**

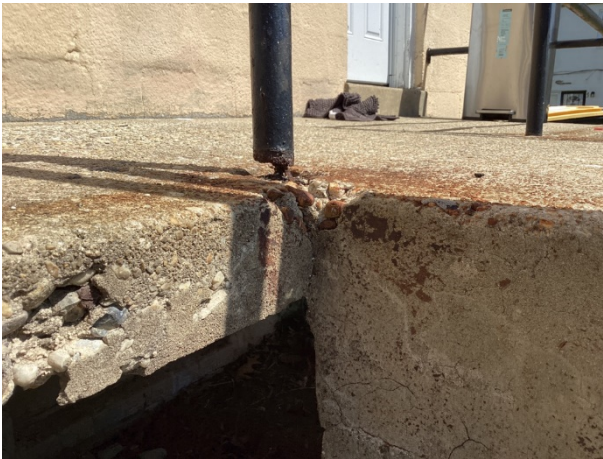
Railing rusted through

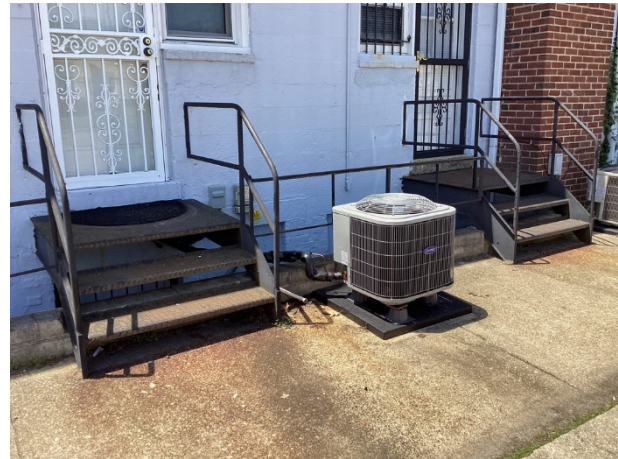
Metal steps near 3918 25th Avenue

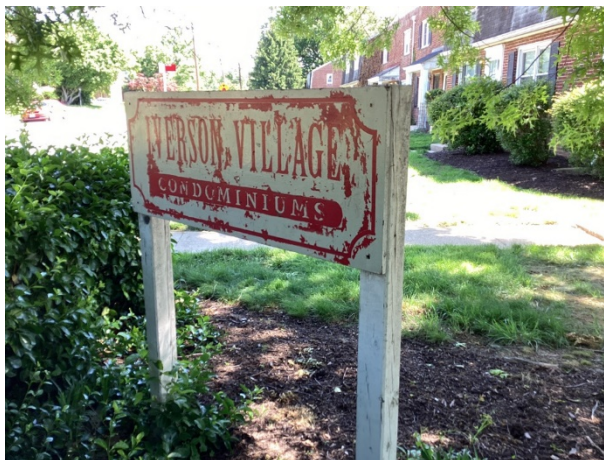
Condition: Fair overall with wear evident

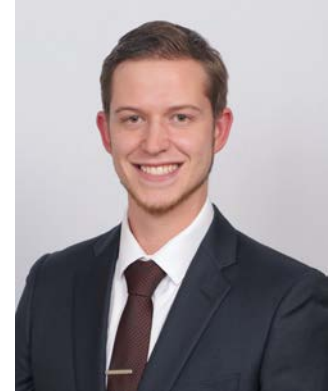
The following is a partial list of clients served by Justin Klein demonstrating his breadth of experiential knowledge of community associations in construction and related buildings systems.
